Manhole Inspection Summary

Manhole # S37SS_031MH

Insp Date: **12/20/06 2:16 PM**

Location Address: **2600 MATHEWS ST**

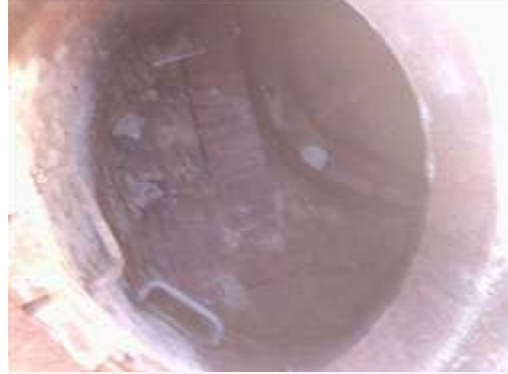
Top View

Evidence of surcharge - Bench debris.

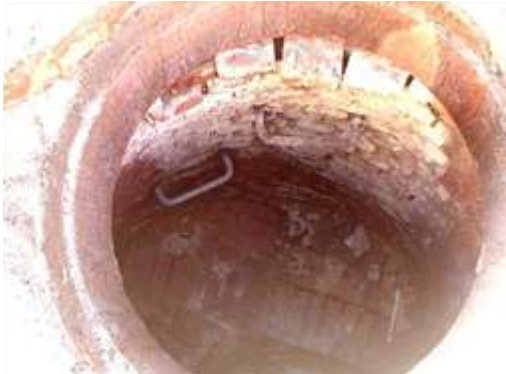
Defect

Frame leaks. Frame offset. Adjustment deterioration, loose brick and infiltration. Corbel deterioration.

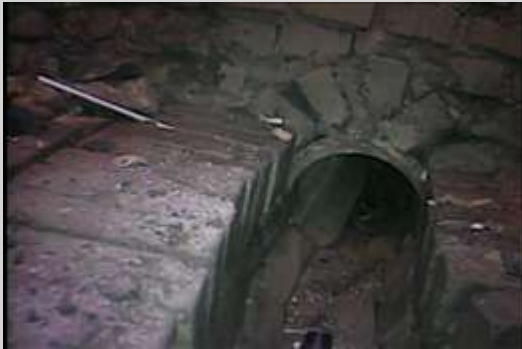
8 in. Circular Gravity Sewer Pipe Out @ 12 O'Clock

Barrel infiltration and deterioration. Channel and Bench deterioration.

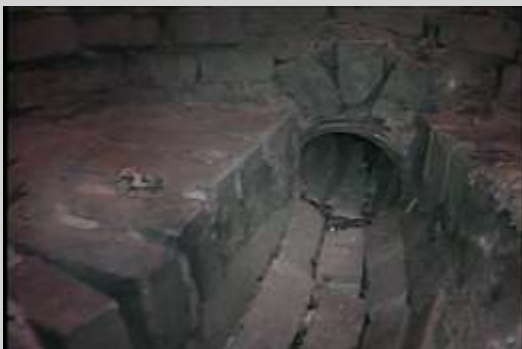
6 in. Circular Gravity Sewer Pipe In @ 4 O'Clock

Barrel deterioration and infiltration. Bench and Channel deterioration.
